**Flood Control Project Maintenance
Levee Inspections****LMA District Cover Sheet****Spring 2013 Levee Inspection Results****Sutter Maintenance Yard East Levee Sutter Bypass**

Spring 2013 Levee Inspection Results

Sutter Maintenance Yard East Levee Sutter Bypass

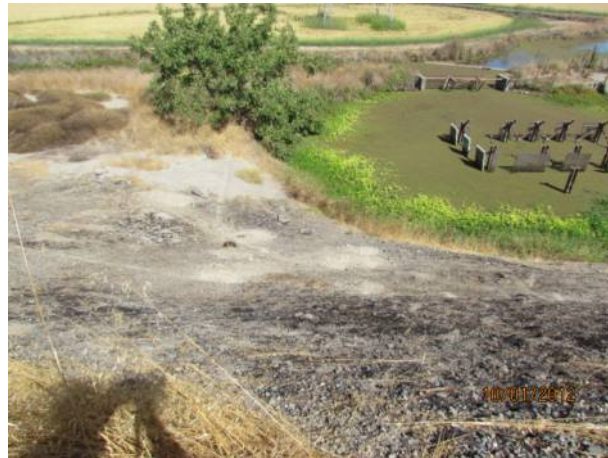
Levee Mile Report Line	4
Start Levee Mile	3.60
End Levee Mile	3.60
Location	Land Side
Category	
Item	Animal Control

View of rodent activity along landside slope.

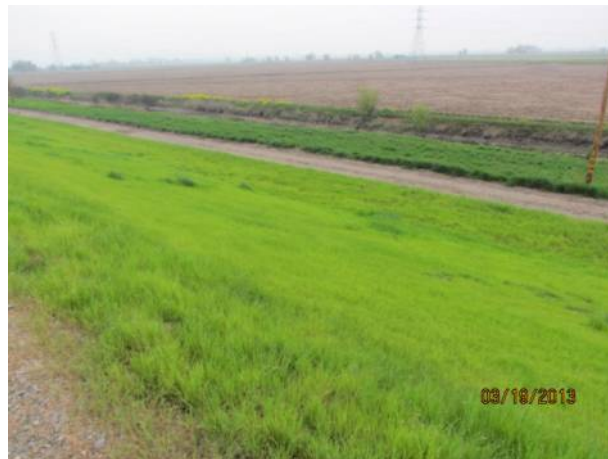
Levee Mile Report Line	5
Start Levee Mile	4.97
End Levee Mile	4.99
Location	Land Side
Category	
Item	Animal Control

View of the grouted rodent holes.

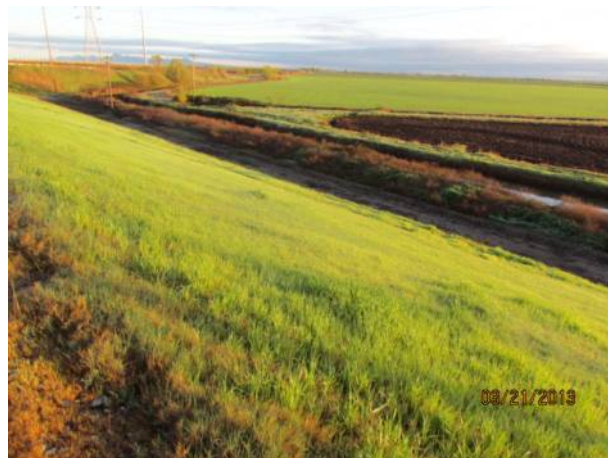
Levee Mile Report Line	7
Start Levee Mile	16.40
End Levee Mile	16.40
Location	Land Side
Category	
Item	Animal Control

View of the grouted rodent holes.

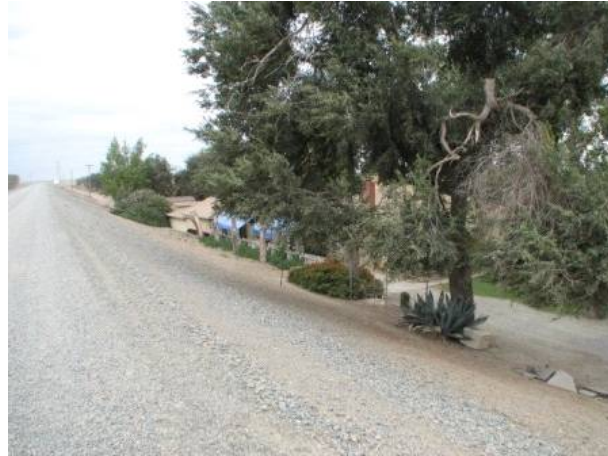
Levee Mile Report Line	8
Start Levee Mile	20.64
End Levee Mile	20.64
Location	Land Side
Category	
Item	Encroachments

View of the building next to the landside toe of the levee.

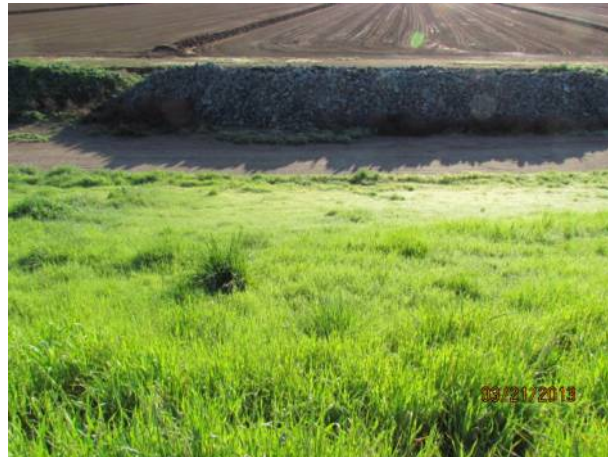
Levee Mile Report Line	9
Start Levee Mile	20.91
End Levee Mile	20.91
Location	Land Side
Category	
Item	Animal Control

View of the grouted rodent holes.
